# CRASH INJURY EVALUATION

SUMMARY EVALUATION

U. S. ARMY HU - 1A

FLIGHT SAFETY FOUNDATION, Inc.

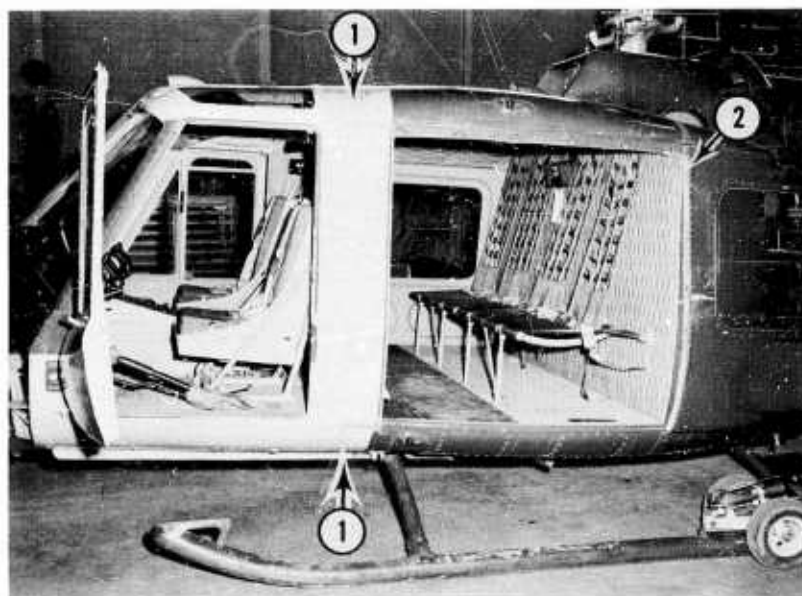
The extreme forward portion of the roof structure of this aircraft is supported by the front door frames and the center strip of the windshield frame structure. The main support is provided by left and right vertical support members shown in Figure 2. The aft end of the roof is supported on a secondary type of structure, the aft firewall bulkhead, also shown in Figure 2.

Figure 2. View of the vertical side supports. Arrow 1 denotes the vertical side support; arrow 2 depicts the aft firewall roof support.

Failure of these main side supports plus the failure of the aft bulk-head support permits the roof structure to lower sufficiently to strike the occupants or the seat backs in the occupiable crew and cabin areas. This is clearly demonstrated by the accident experience where the side vertical supports failed in every one of the five accidents, ranging from partial failure in Accident "C" and Accident "E" to complete failure in Accidents "A" and "D" (Figures 3 through 18). The aft end of the roof also failed in all but one of the five accidents (Figures 19 through 24). Only the absence of forward deceleration probably precluded any forward movement of the aft roof supporting structure in Accident "E".

It is evident, therefore, that the strength requirements of both the main side supports and the aft bulkhead support are inadequate. They should be able to withstand impact forces and conditions of a survivable nature without gross failure. This apparently has been recognized recently by both the military and the manufacturer. "Requests for Alteration" have been studied by the Bell Helicopter Corporation on each of these two features.

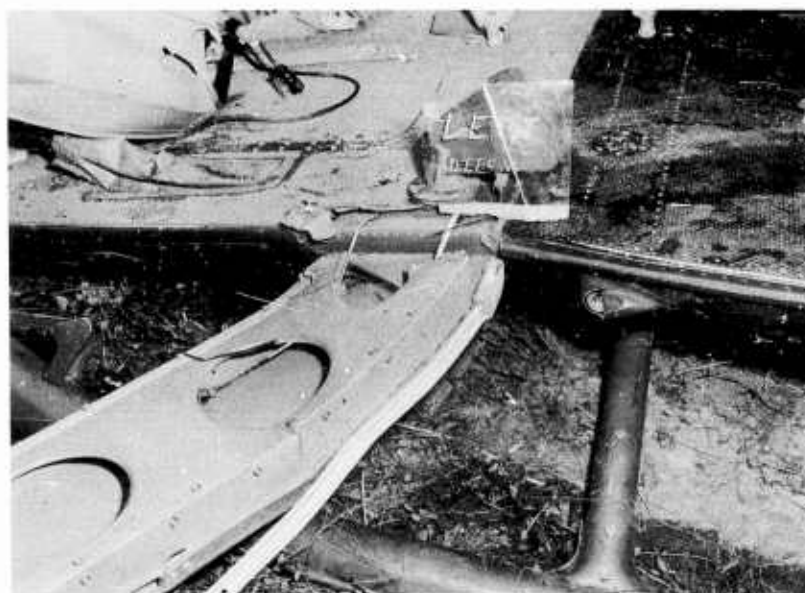
Figure 13. The entire left side support in Accident "D" was torn free with the exception of the wiring.

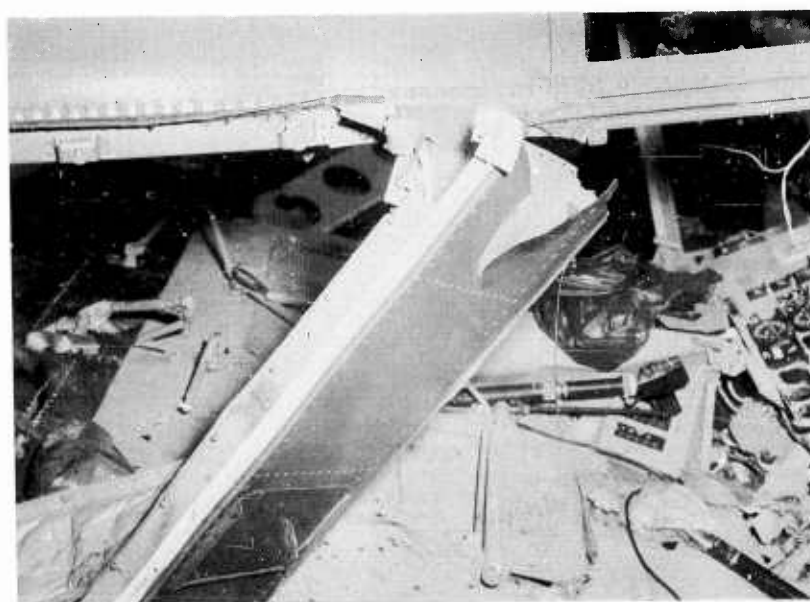
Figure 15. The top of the right side was supported by the wiring, Accident "D".

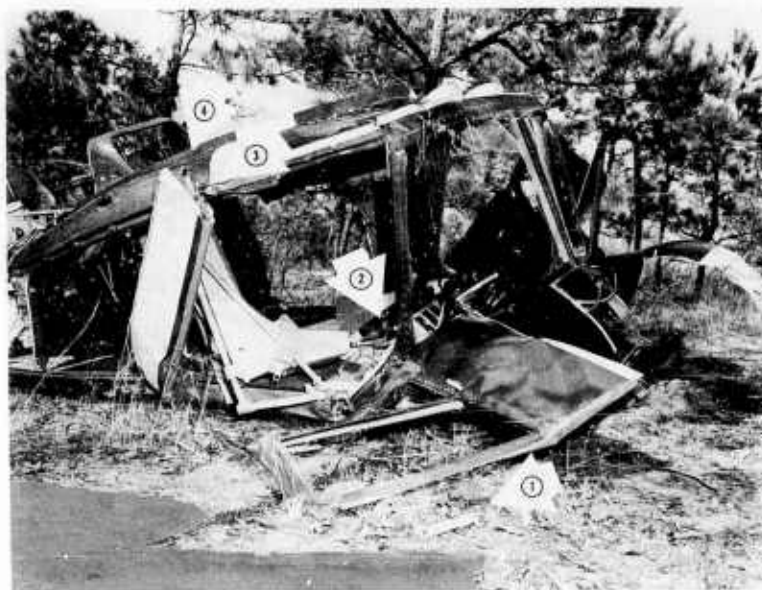
Figure 20. The collapse of the aft bulkhead allowed the roof structure to impinge into the occupiable area in Accident "B".

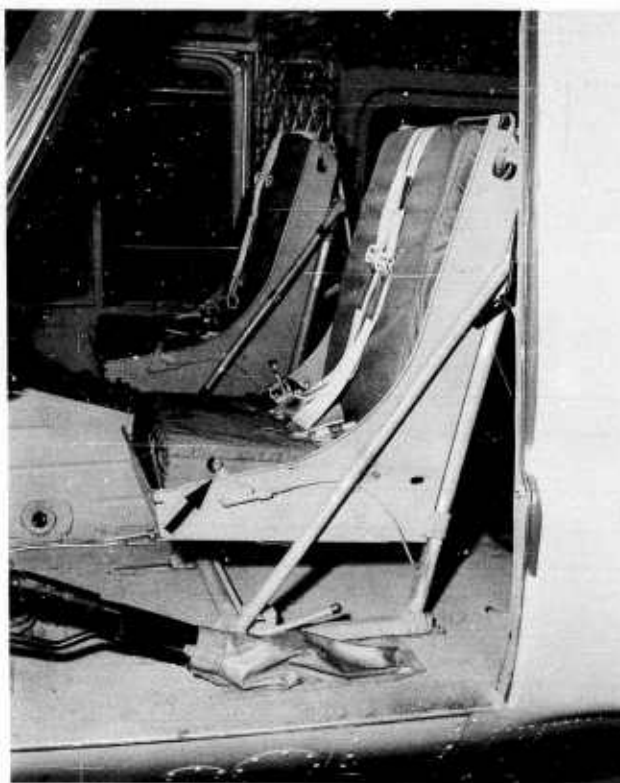
Figure 35. A side view of the pilot's seats. The inertia reel manual locking lever is conveniently located on the side of the seat pan (arrow).

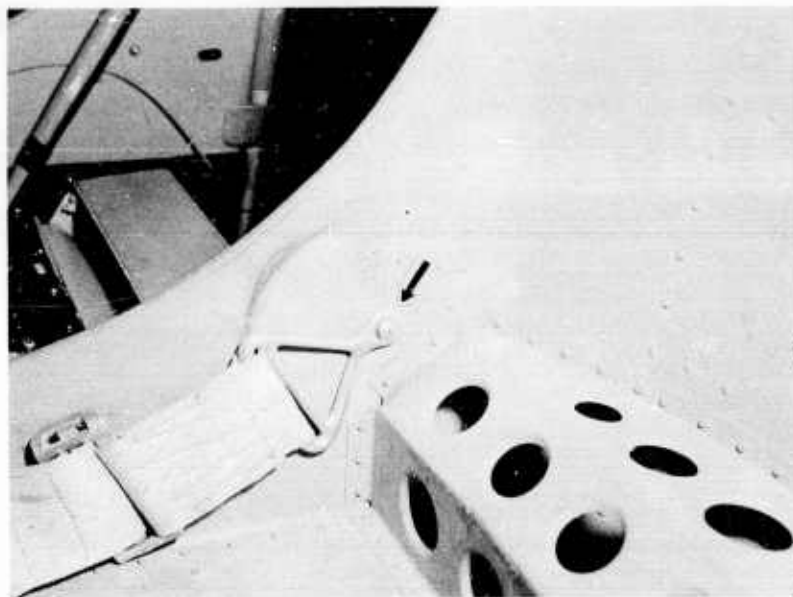
The safety belts on the crew members' seats are attached to the sides as depicted in Figure 36. A reinforcing plate is attached to the outside of the seats for additional strength. It should be noted that this safety belt attachment is not an omni-direction attachment. Helicopters frequently encounter side loads during an accident, and this type of anchorage would have a prying effect on the attachment with possible end attachment failure. It is suggested that the end attachments incorporate a self-aligning omni-directional anchorage.

Figure 36. Close-up of the safety belt end attachment (arrow). The metal baffle type structure is also depicted.

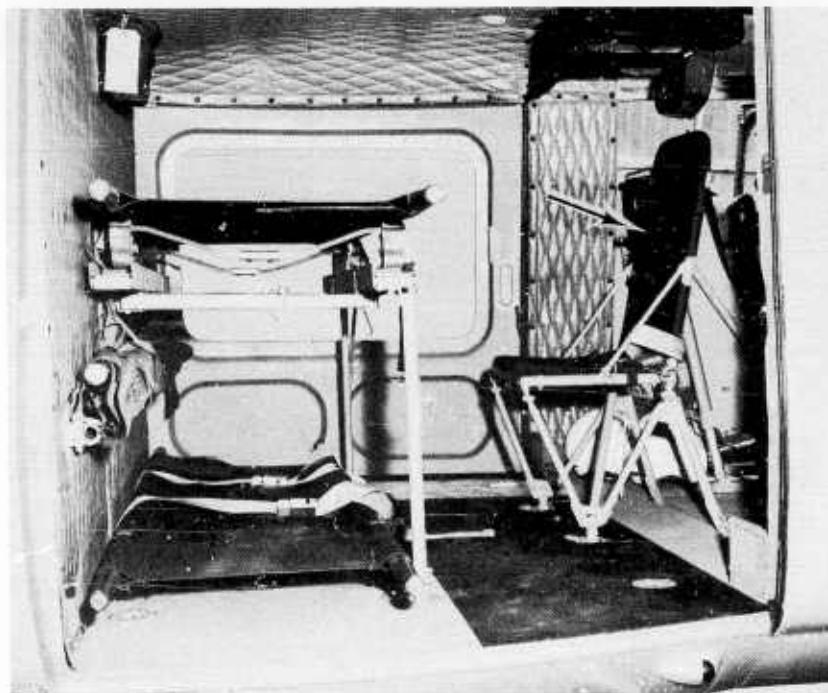
This seat is located just aft of the pedestal and was primarily designed as an aft facing Medical Attendant seat (Figure 47). In some cases the seat is reversed, forward facing, and is utilized by the crew chief. The safety belt is attached at the junction of the seat back and the seat pan and is stressed for 5.0G aft and 10.0G side loads when utilized in the aft facing position.

Out of the five accidents, this seat was installed and occupied only in Accident "D". In this case, the seat was attached facing forward and occupied by the Crew Chief. Upon impact the seat tore free from its leg attachments and permitted the Crew Chief and seat to be hurled out through the windshield.

Figure 47. View of the Crew Chief/Medical Attendant seat mounted in an aft facing position (arrow).

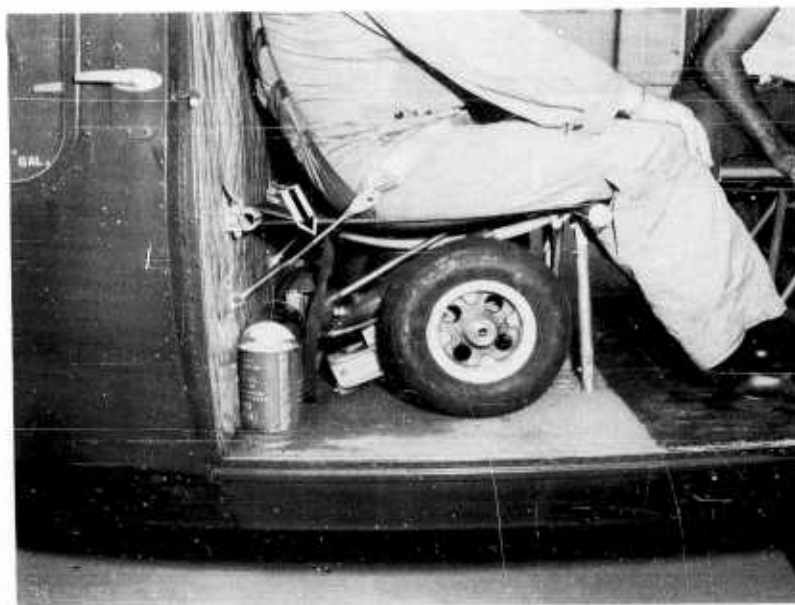
Numerous investigations and evaluations have shown that the cabin occupants' seat belts are being attached to an "O" ring which is attached to a rear longitudinal seat support. The correct and incorrect manner of attaching the seat belts in this aircraft is depicted in Figures 53 and 54.

The belts are stressed to withstand 11.0G at a 45-degree angle upward, forward, and inboard. The seat belts should be attached to the cables which are tied directly into primary structure (Figure 54).

Figure 54. The correct manner in which the safety belt should be installed in the HU-1 and the HU-1A is depicted by the arrow. Note that the belt crosses the hips at approximately 45°.

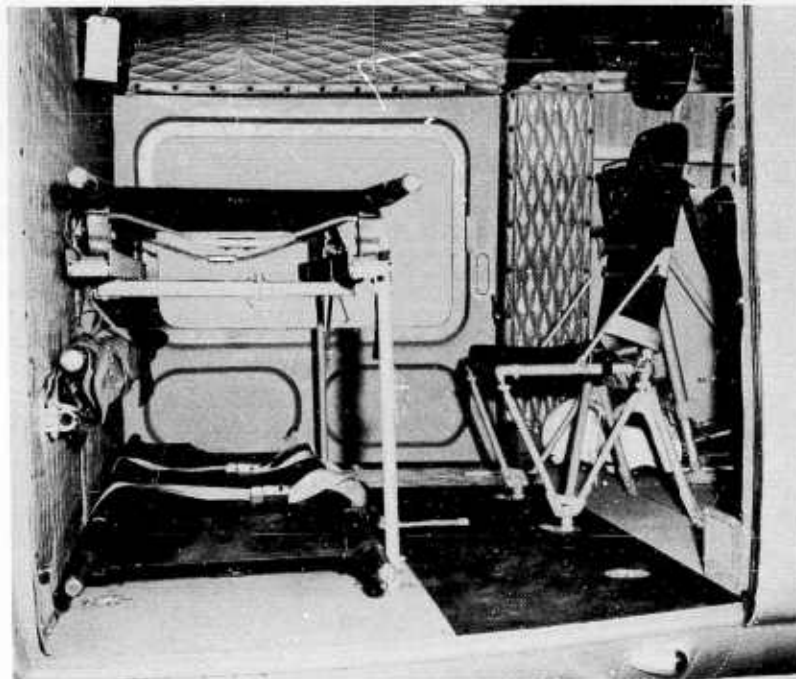
Figure 55. Over-all view of the litters and supporting frame.

The current litter configuration and installation should be dynamically tested with full-scale anthropomorphic dummies under force magnitude, direction, and time history conditions associated with survivable crash loads sustained in helicopter accidents. The results of these tests should be utilized in the development of a more suitable specification.

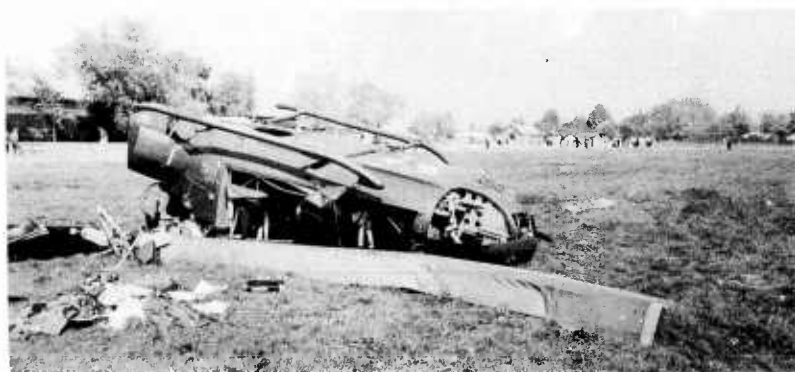
The helicopter had completed a high-speed run parallel to and in front of the spectators when the pilot initiated a cyclic climb to approximately 500 feet above the terrain to prepare for an autorotative descent. Upon arriving at the desired altitude with a velocity of 30 to 40 knots, he made an 180-degree turn, reduced power, lowered the nose of the aircraft, and entered autorotation. Immediately after entering the maneuver, the pilot noted an unusually high rate of descent, at a point estimated to have been 200 feet above the terrain. He leveled the aircraft, applied full power and collective pitch, but was unable to decrease the high rate of vertical descent. He continued application of power and pitch, and just prior to the crash, succeeded in partially reducing the high "sink" rate. At impact the tail boom began shearing loose and tore completely free as the aircraft rebounded into the air. The aircraft struck the ground two more times, finally coming to rest in an inverted position approximately 420 feet from the point of initial impact. During this sequence the engine tore free from its mounts and rolled far to the right of the crash path. Cargo and cabin doors were torn free. The main transmission, mast, and rotor assembly tore free during the rolling of the aircraft near the end of the crash path. The roof failed in compression, collapsing against the seat backs of the pilot and crew chief's seats. (It is reasonable to assume that the vertical side supports failed at initial impact. This is substantiated by the four other accidents that did not become inverted.) The forward deceleration was approximately 3.9G; the vertical load sustained was approximately 9.8G upon impact.

Over-all view of the East St. Louis, Illinois accident

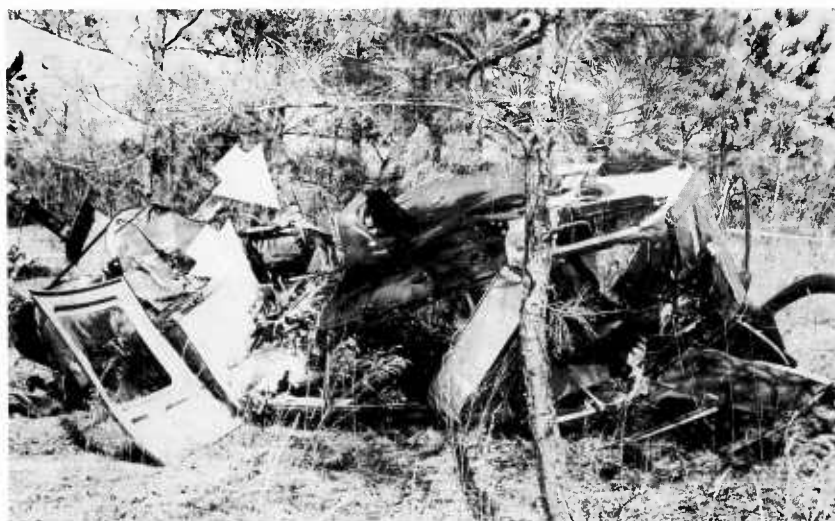
During a climbing right turn with approximately 60 knots indicated air speed and at about 250 feet above the ground, the pilot thought he smelled something burning. He reached up with his left hand to the overhead panel and turned off the aircraft heater, at the same time looking up to make sure he had the right switch. As a normal reaction to the outstretching of his left arm, he involuntarily applied a small amount of right forward cyclic, not realizing it because of the servo flight control system and the absence of force trim. This put the aircraft in a nose low attitude, increasing the air speed and allowing a rate of descent to build up to approximately 1,300 feet per minute. It also turned the aircraft downwind and picked up a 12-knot tail wind. By the time the pilot got his attention back and realized the attitude the aircraft was in, he was descending rapidly into a patch of trees which he reported were only about 50 feet away when he first saw them. His ground speed was in the neighborhood of 95 knots and with the rate of descent near 1,300 feet per minute, the aircraft had no time to respond to his control before hitting the trees and the ground. Just prior to ground contact the main rotor blade wrapped around an oak tree and pulled the transmission free of the aircraft. The aircraft continued on, striking the ground, bounced, and came to rest 20 feet from initial contact. The decelerative forces in this accident were estimated to be in excess of 14G's.

The HU-1 accident, Fort Rucker, 4 March 1960

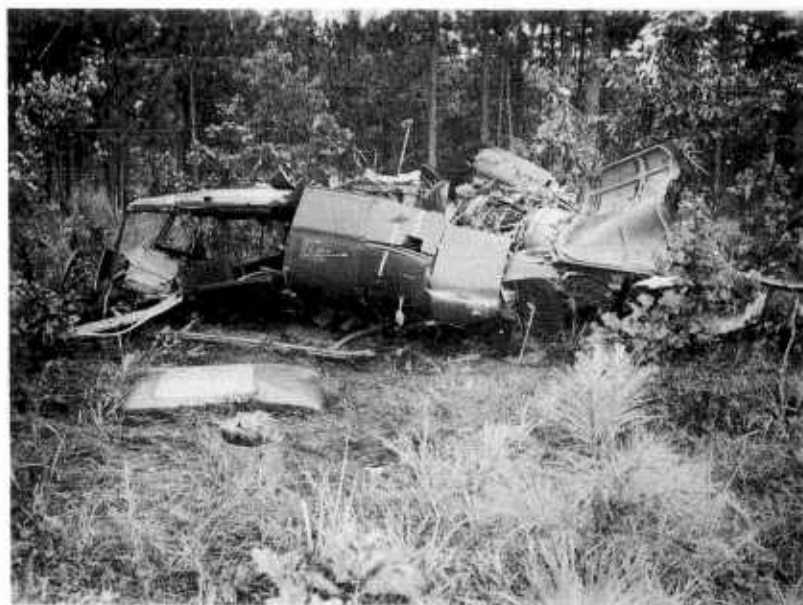
The pilot, having entered the downwind leg for the intended landing site, felt the aircraft settle and immediately noticed a drop in rotor R. P. M. While at approximately 200 feet, he immediately lowered the nose to maintain rotor R. P. M. and committed the aircraft to a forced landing. The immediate area consisted of 50 to 60 feet high pine trees. As the aircraft entered the wooded area, a nose high, full flare was initiated prior to the main rotor severing a 10-inch diameter tree approximately 35 feet above the ground. From this point the aircraft settled in a tail low attitude until striking the ground. During this latter sequence the cabin area just aft of the pilot's seat on the right side was impaled on a stump approximately 10 inches high which penetrated into the inhabitable area. Accurate measurements were unobtainable due to a continuous rain which eliminated most of the gouge marks although evidence indicates the vertical load sustained was approximately 14G while the longitudinal force was approximately 4G.

Side view, HU-1A, Fort Bragg, North  
Carolina, 20 August 1960

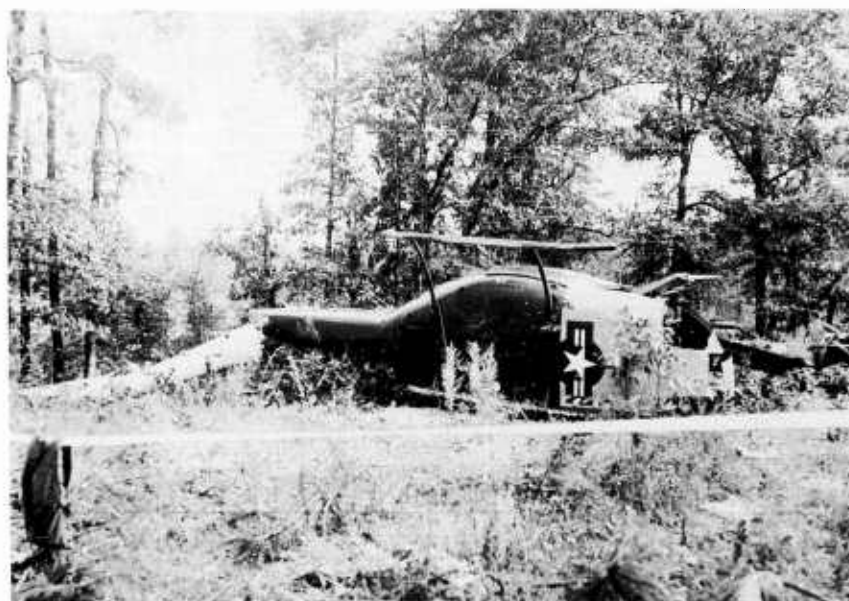
While in level flight at cruise power, the crew heard loud banging noises followed by moderate oscillation of the aircraft through all axes. Upon increasing collective pitch and power the helicopter started to yaw. The pitch control was immediately reduced to minimum and the pilot checked his anti-torque pedals. When no response was forthcoming, he then realized he had lost his tail rotor. He turned toward the runway which also placed the clearest available area in his flight path. Yaw control could only be maintained with the pitch bottomed. The pilot, realizing he could not make the runway, elected to head for the clearest area available. When approaching touchdown, a flare was executed to reduce touchdown speed. As the speed was reduced, the yaw increased to the left. The aircraft hit the top of several oak trees moving forward and downward through the trees. The initial impact with the trees was about 50 feet above the ground. The aircraft stopped its forward motion after about 110 feet while 15 feet above the ground. At this point it rolled over on its left side and fell vertically, coming to rest on its left side. Accurate gouge marks were unobtainable although evidence indicates the load sustained in this accident was between 5G and 10G.

View of the HU-1A accident which occurred at Fort Rucker, Alabama, 26 August 1960.
